# REDESIGNED BIOSWALE SYSTEM FOR BIG BOX RETAIL

Recently, Divisions took over care of a bioswale system for a big box retailer in Richmond, IN. Originally outside Divisions landscaping scope, malfunctions with the system were compounding over time creating a pressing need for overhaul. The bioswale was originally designed to manage and filter runoff water in their parking lot. As an alternative to storm sewers, if maintained, these vegetative filter buffers have proved to be an effective drainage method, designed to move and temporarily store runoff water and filter out pollutants, improving water quality. These swales are designed with sloped sides, filled with native vegetation, proper soil mixture, and a variety of rock. The water's flow path, along with the wide and shallow ditch, is aimed to maximize the time water spends in the swale, which aids in the trapping of pollutants and silt.

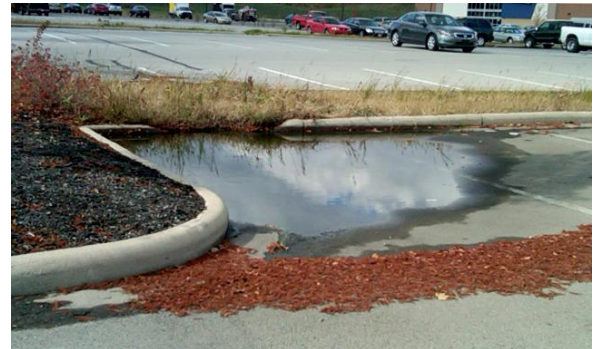
Directly behind the Richmond, IN store is a [neighboring arboretum](#) which sits on 466 acres of woodlands, meadows, swamps, and streams that can be enjoyed by the public. Because the water from the swales ultimately feeds into the arboretum the quality of the retailer's water runoff is of concern. Besides becoming unsightly, the original bioswale installation could no longer drain or filter water properly – resulting in flooded parking spaces and stagnant standing water. (See Figure 1) These concerns drove the retailer's corporate landscaping team to begin planning the reconstruction of the bioswales.

Figure 1: Standing Water

Immediately, Divisions Maintenance Group took action to assist in designing the new bioswale system. To assure the system was installed properly, Divisions invited and encouraged the city to participate in frequent monitoring of the site, which was usually done on a daily basis. Anytime there were modifications to the original landscape project, Divisions would walk the site with the city and receive approval on any work done. The new system was installed and the bioswales were transformed into the beautiful, functional conveyance system that was originally intended. In addition to the bioswale work, Divisions also corrected the grading of the parking lot, which now allows rainwater to flow more freely into the bioswale. (See Figure 2) Divisions is now responsible for maintaining the bioswale system with chemical free applications and regular upkeep and special care to the 1300 native plants that now grow in the installation.

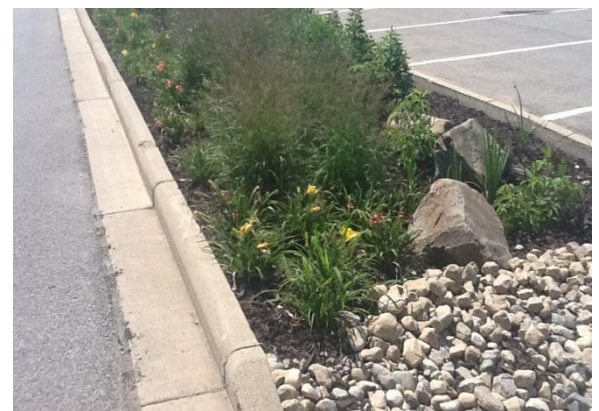
Figure 2: New bioswale installation
